INSPECTION REPORT

-Description and Quantity of Commodity: 324 pieces steel sheet pile

Nov.12, 2015 at Nanjing City, Jiangsu Province, P.R.China

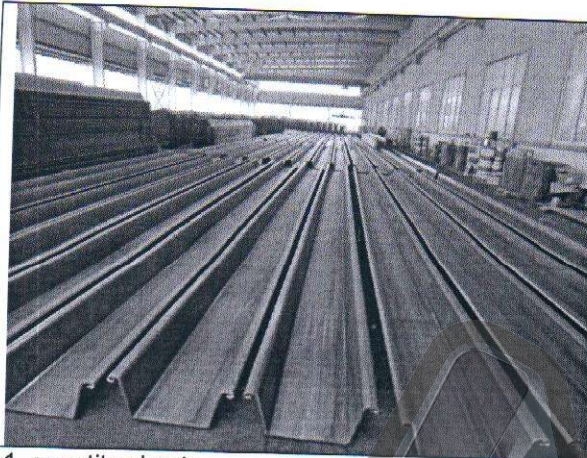
The product quantity was checked by SGS inspector at manufacturer's workshop. Total 324 pieces steel sheet pile (product type was 600*200*10) were found at manufacturer's warehouse. The total quantity and product type were conform to the requirement

1, quantity check

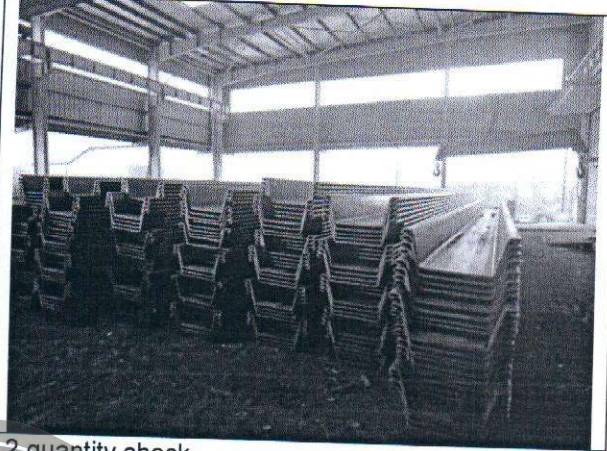
2, quantity check

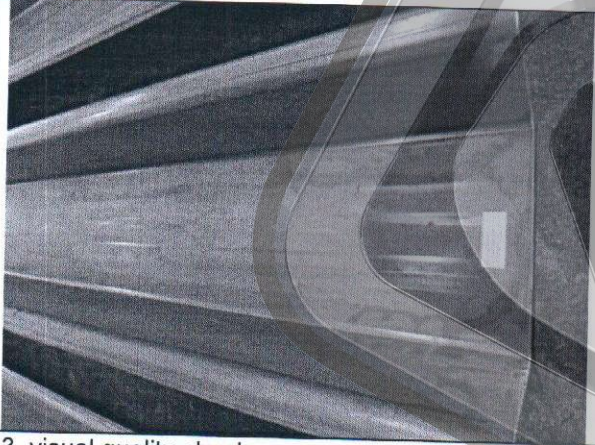
Visual quality was randomly checked by SGS inspector during this visit. Detail findings as below:

3, visual quality check

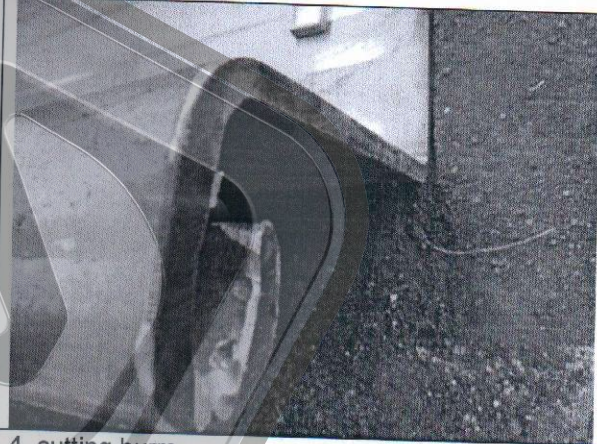
- ✓ Slight scratch was found on the product surface.
- ✓ The end of sheet piling was grinded but several cutting burrs still exist.

4, cutting burrs

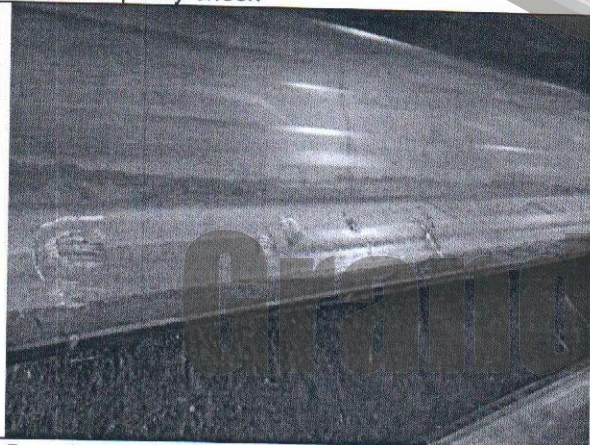
5, surface scratch

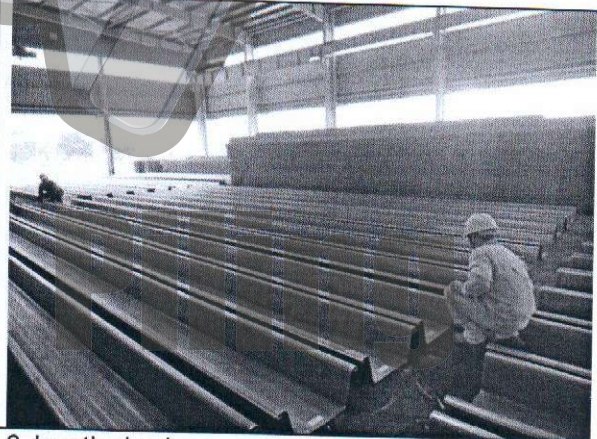
The length, width, height, wall thickness was checked by SGS inspector as required. Detail as below:

- 1, The measurement conform to the required tolerance of EN10249-1995.

6, length check
